**SUBJECT:** 988X and 989X PA Modification Kit, PN 250-9884-533

**Radio Models Affected:** High power (30W) 800 and 900 MHz radios with a date code before April 1, 1999 (139). The 30W high power model is identified by the "2" in the 5<sup>th</sup> character of the serial number. The date code is the 7<sup>th</sup> through the 9<sup>th</sup> characters. The 7<sup>th</sup> and 8<sup>th</sup> characters represent the week of the year and the 9<sup>th</sup> character represents the last digit of the year.

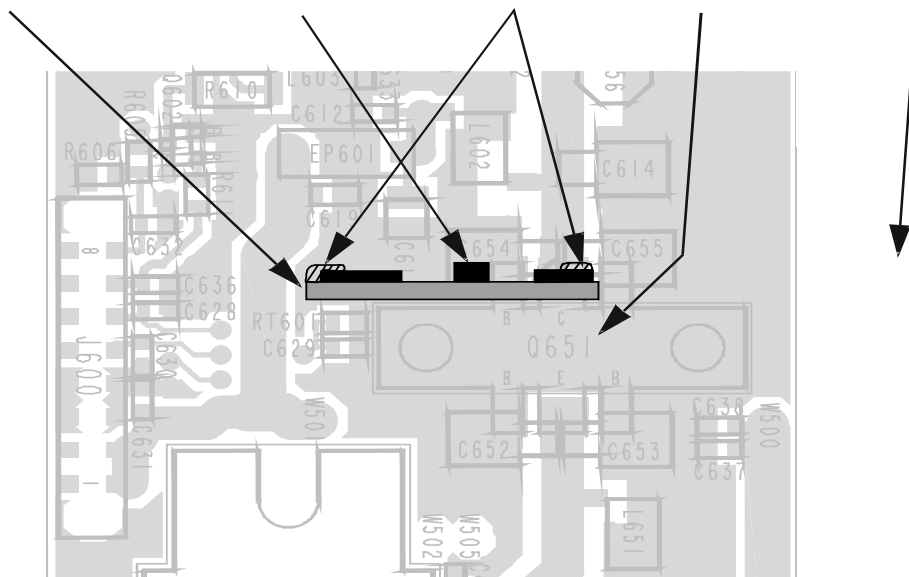
**Background:** Some early high power model 988X and 989X radios would exhibit a loud "squeal" while transmitting. Analysis revealed that VSWR instability was the source of the problem. A small PC board assembly was added to the PA to improve VSWR stability.

3. Position the PC board assembly from the kit in the location shown above. Make sure that the component side of the board is facing away from Q651.
4. Solder the tabs of the board to the collector and ground leads of Q651. The solder should wick up slightly on the board tabs.
5. Replace the shield cover. Transceiver retuning is not necessary after installing this board.
