Field Advisory

Subject: Loose Screws on bottom of 778x and 81xx portables.

Models Affected: 242-778X-XXX
242-81XX-XXX

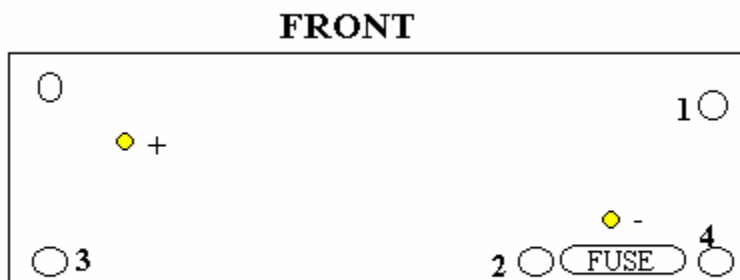
It has been discovered that screws may be loose and cause intermittent operation. The radio could cycle power after being bumped. Low battery indications may exist due to improper grounding causing the radio to think it is in a low voltage state.

Remove the battery to expose 5 screws on the bottom side of the radio. The grounding lug is located under screw marked #1. The B+ line to the radio is located under screw marked #4. Screw #2 is from the battery + terminal. Tighten these screws until snug. Care should be taken not to over-tighten these to prevent stripping.
