Field Service Bulletin

Subject: 5300 SEM or UCM model mobile radios shipped through August 23, 2004
Units can be identified by the serial number revision letter. Affected units are rev G or H.
Example: 53170G164A 12345

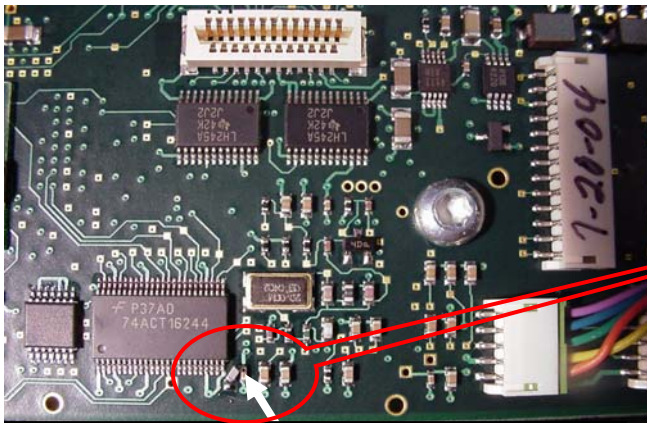
EFJohnson has recently made modifications to the 5300 SEM or UCM model mobile radios, to prevent possible lock ups. This problem was discovered as a result of our on-going field service and development activities. Any 5300 SEM or UCM model mobile radio shipped prior to August 23, 2004 will require at least a software upgrade and in some cases, a hardware upgrade.

The addition of a 470pf capacitor to the SEM/UCM board:

Add 470pf cap on SPICLK line to 5v supply

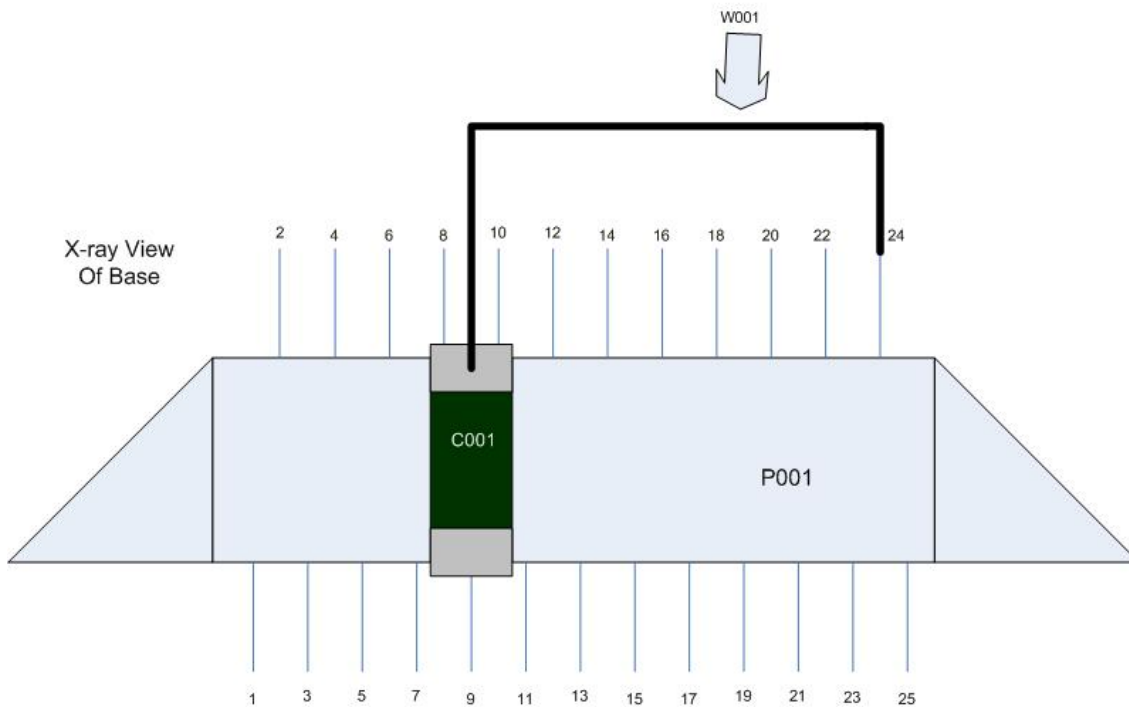
094-5300-699

The moving of a jumper on the SEM/UCM board:

Moved attached wire on assembly from pin 25 (EMC_Wakeup) to pin 24 (GND)
