# *Field Software Notice*

To: **Conventional Systems Users**  
Subject: **Software Release**

Platform: **2600 Repeater**  
Protocol: **Conventional**  
Version Release #: **2.6.8**  
Supersedes Version#: **1.26.4/2.6.5**  
Effective Release: **June 21, 2007**

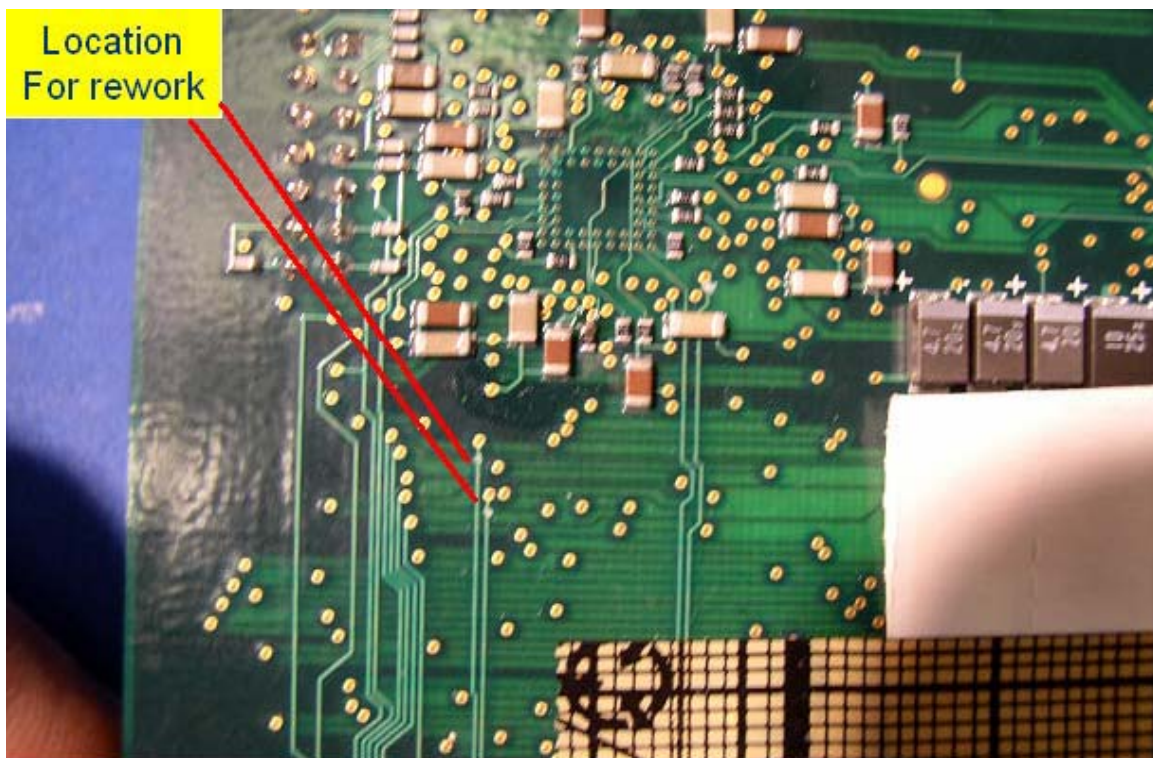
Verify traces are cut.

Before updating a 2600 repeater from version 1.x to version 2.6.8 verify that the controller card has all the ECOs (Engineering Change Orders) required bringing it up to Revision 5, or that a Revision 5 board is currently installed in the repeater. During development of version 2.x.x 2600 software, problems with repeater lock-ups and the inability to program flash were traced to contention between the DSP and Power PC for a shared memory buss line. On updated controller boards, traces should have been cut to remedy the contention problem. If the traces have not been cut, the controller board needs to be swapped out with a current Revision 5 board. **Old boards need to be returned to EFJohnson's Repair Depot for rework.**

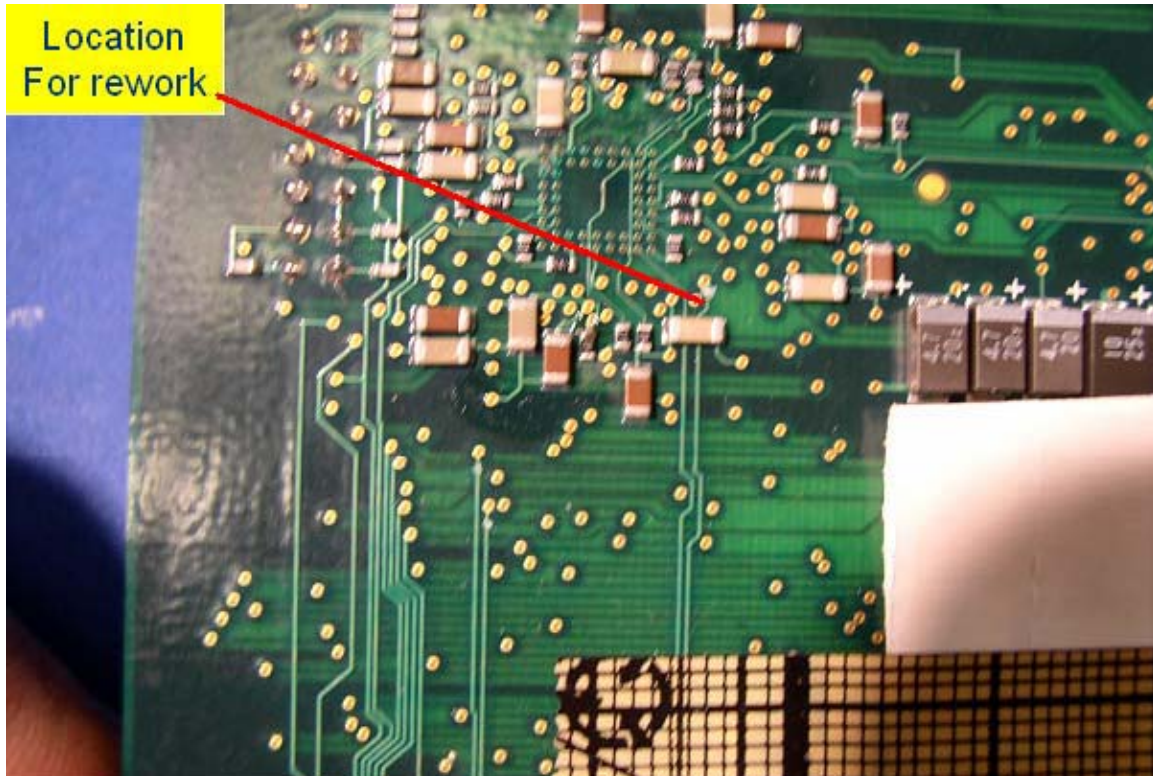
Verify traces are cut.

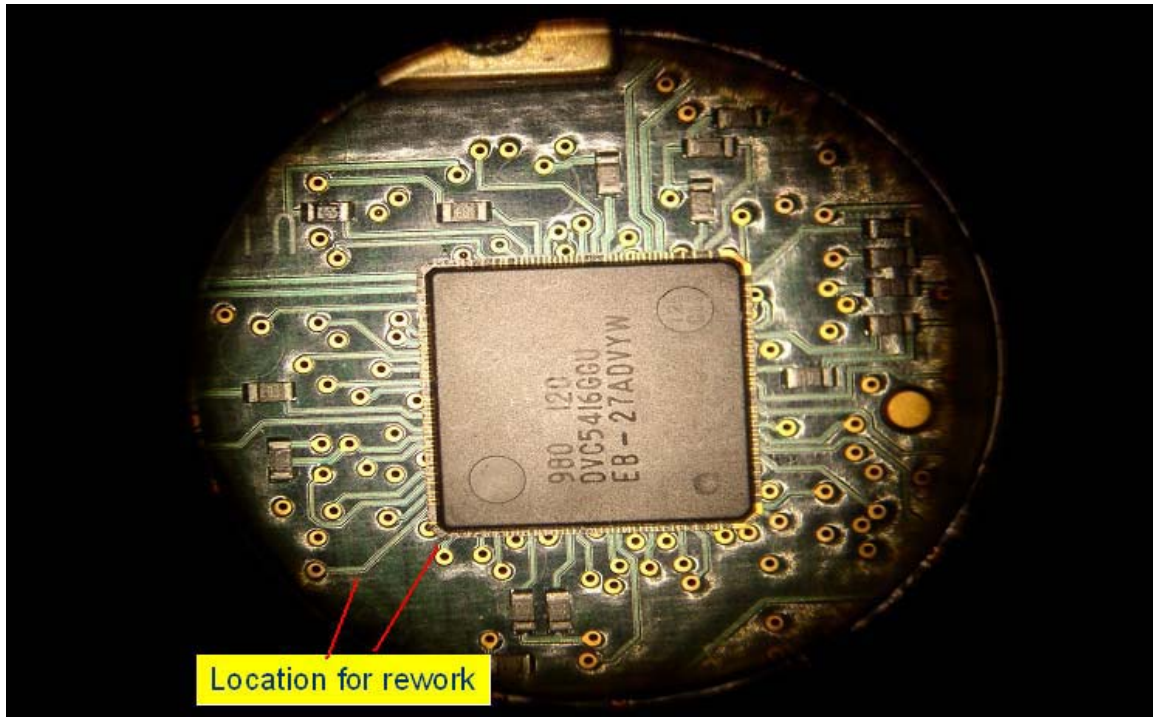
Verify traces are cut.
