Service Bulletin

Subject: Time Drift in IP25™ System Components

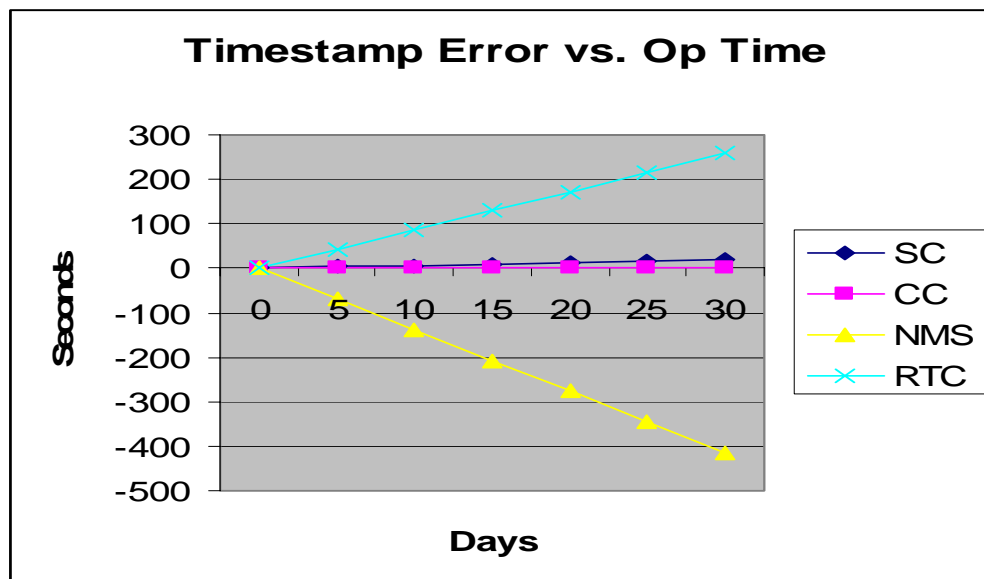
The net effect of these errors causes decreasing time precision within the system during operation. Refer to the following chart that shows a typical difference in time between the SC timestamp and the NMS time in just 30 days to be approximately 7 ¼ minutes. This assumes a 0 initial set error.

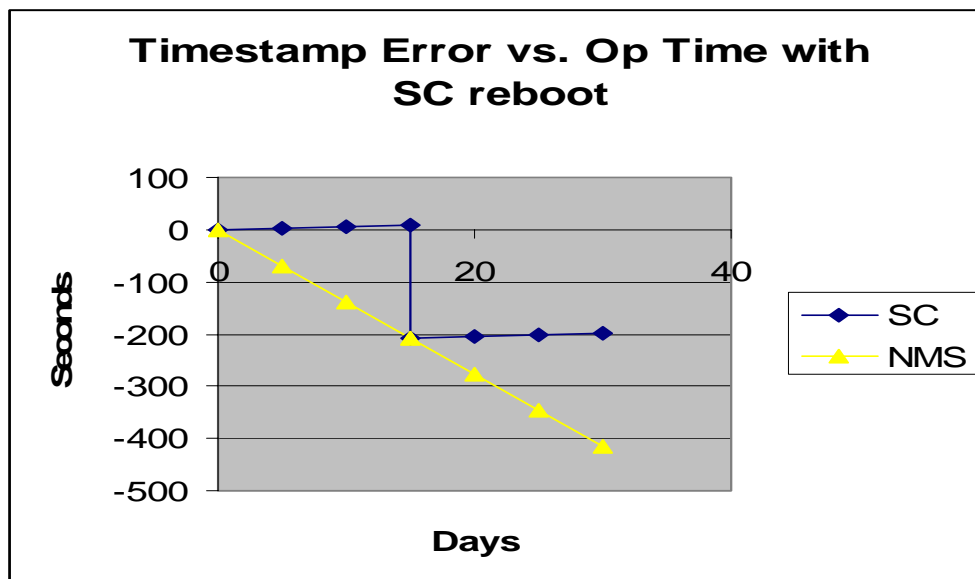
The following chart shows the effect when the SC is rebooted after 15 days, under the same conditions. Note that the difference in time between the SC and the NMS is cut approximately, in half, but now the SC error has increased significantly to approximately 3 ¼ minutes due to the re-synch to the incorrect time at day 15.
