Field Service Bulletin

To: Users of EFJohnson Clamshell Battery for the 5100 Portable Radio

Subject: Field Modification

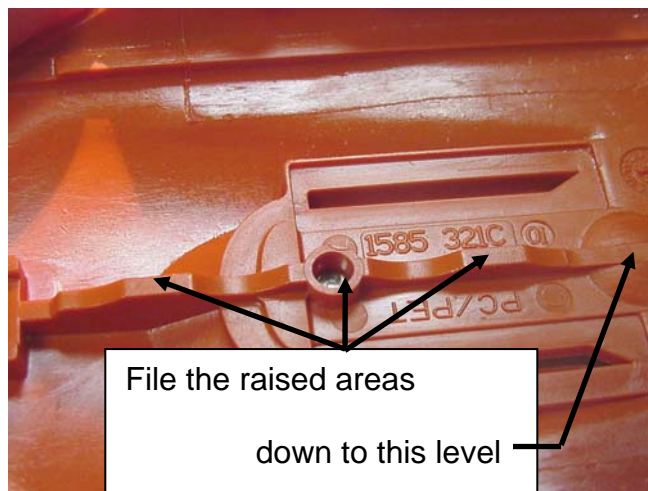
EFJohnson has received complaints that the orange clamshell battery cover can be difficult to remove under some field conditions.

The solution to this issue is to remove the scallops on the inside of the orange covers. This can be a field modification using a file or grinding tool, or the covers can be returned to the EFJohnson factory where the scallops will be ground off. Removal of the scallops does not affect the fire certification of the clamshell battery or the radio.

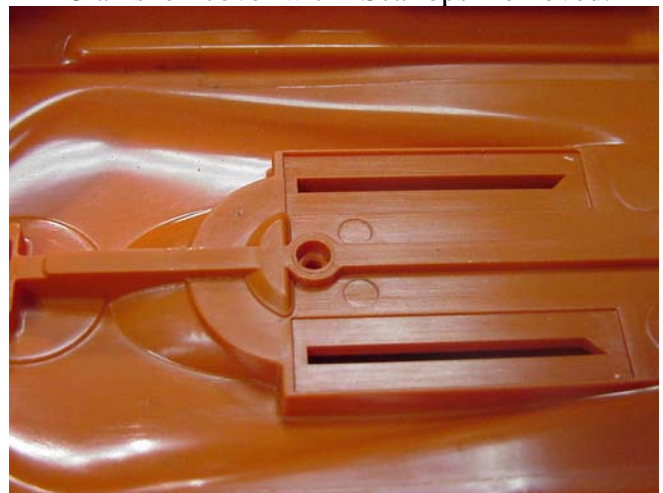
Clamshell cover with "Scallops" removed.
